# A-6 Intruder

# WALK AROUND

**By Lou Drendel**

**Walk Around Number 2  
squadron/signal publications**

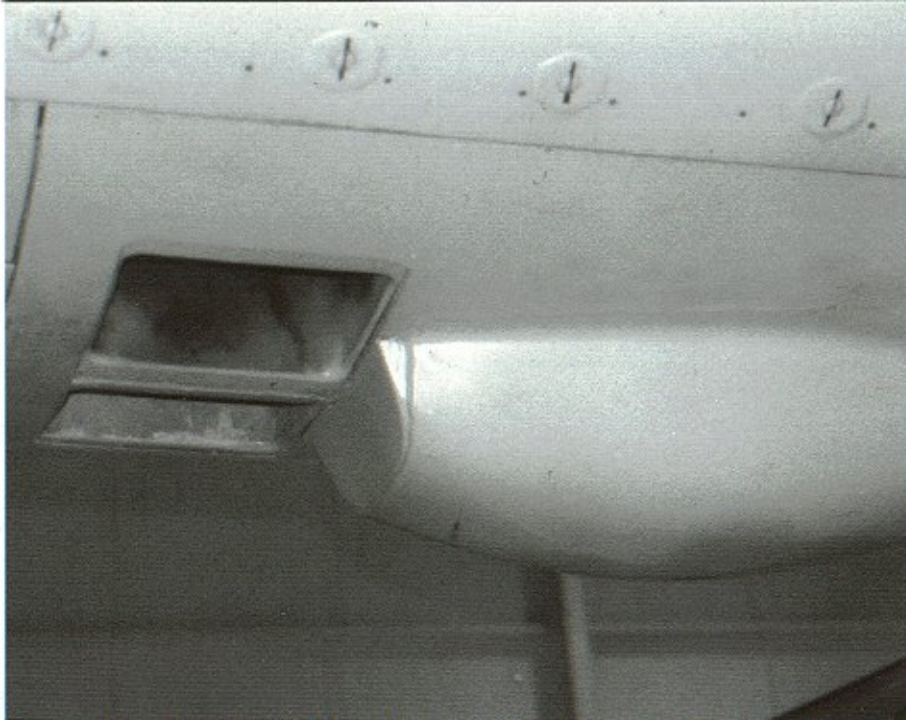
The Doppler radar radome (starboard side) and MX-7721/ALE-29A Chaff/Flare dispenser ports are located under the mid-fuselage, just ahead of the tail hook.

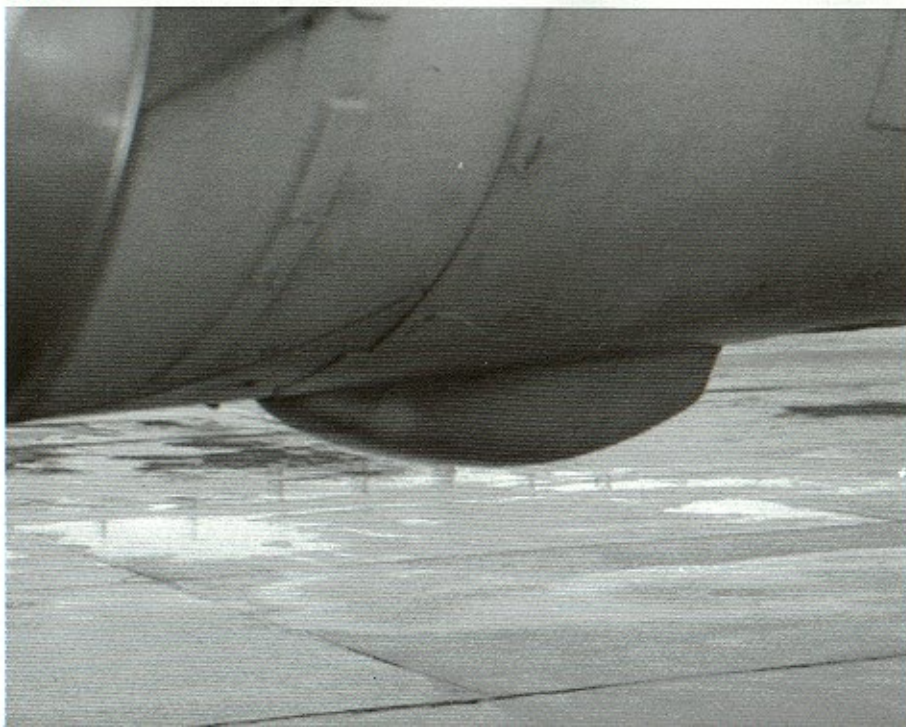
The small under-fuselage radome houses an APN-153 Doppler navigation radar antenna. This radar is used to provide navigational update information for the inertial navigation system.

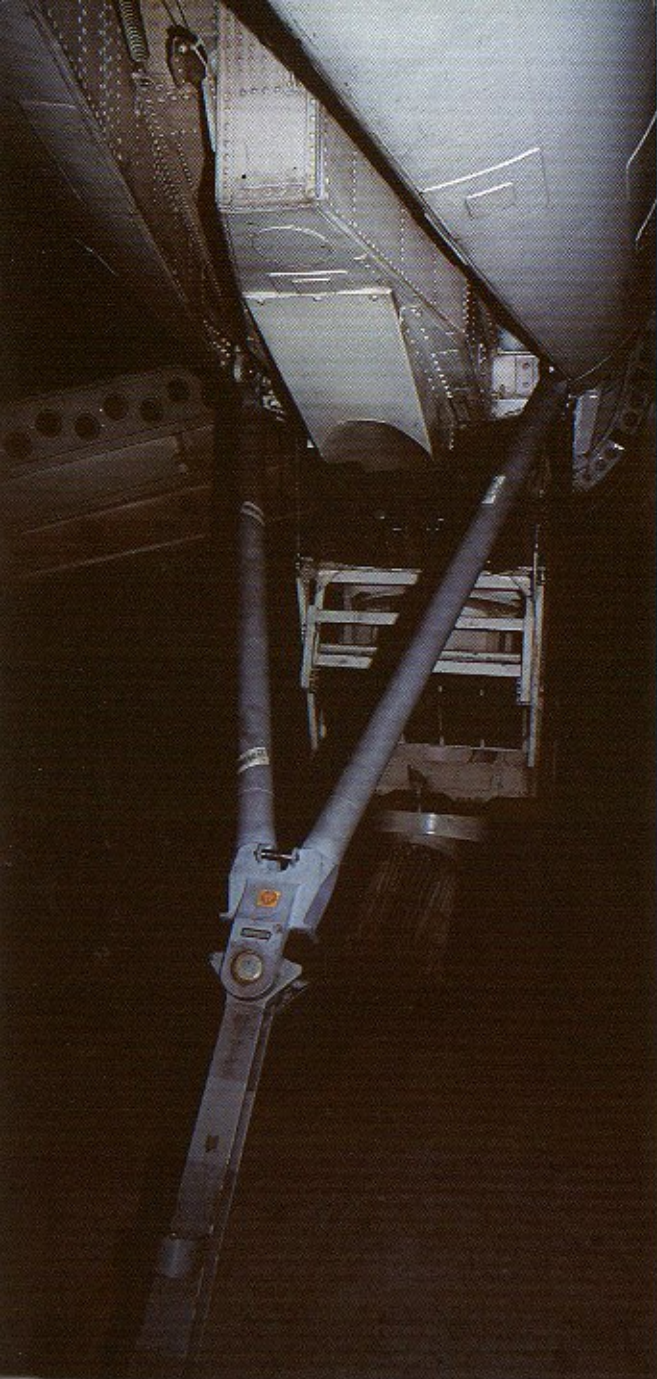
The Y frame tailhook of a KA-6D tanker in the lowered position. The curved fairing in front of the tail hook is the hose guide for the Hose/Drum refueling unit.

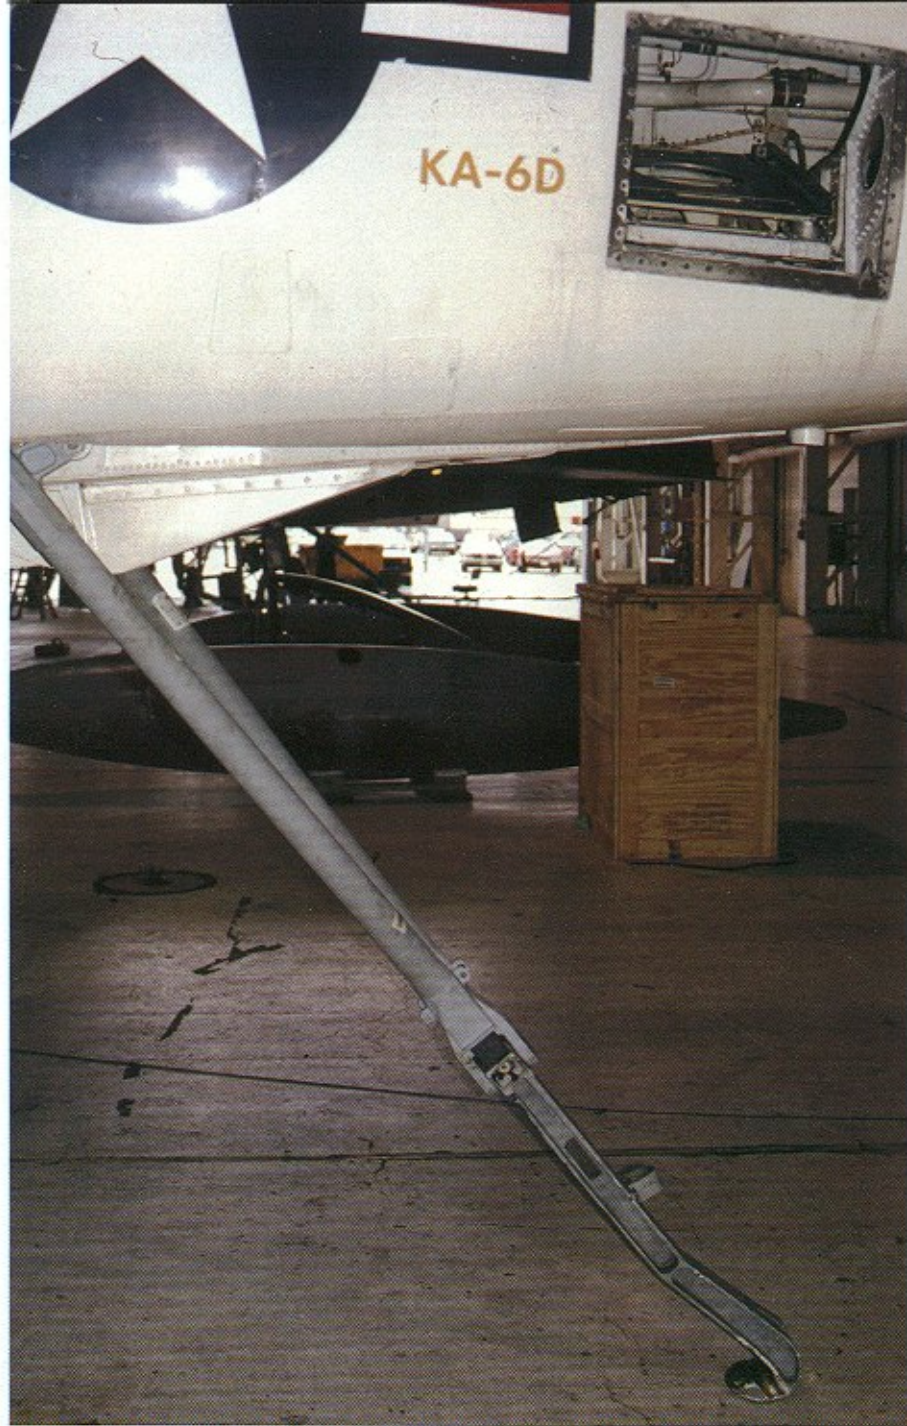
The open access panel above the lowered tail hook of this KA-6D houses Electronic Countermeasures (ECM) transmitters.

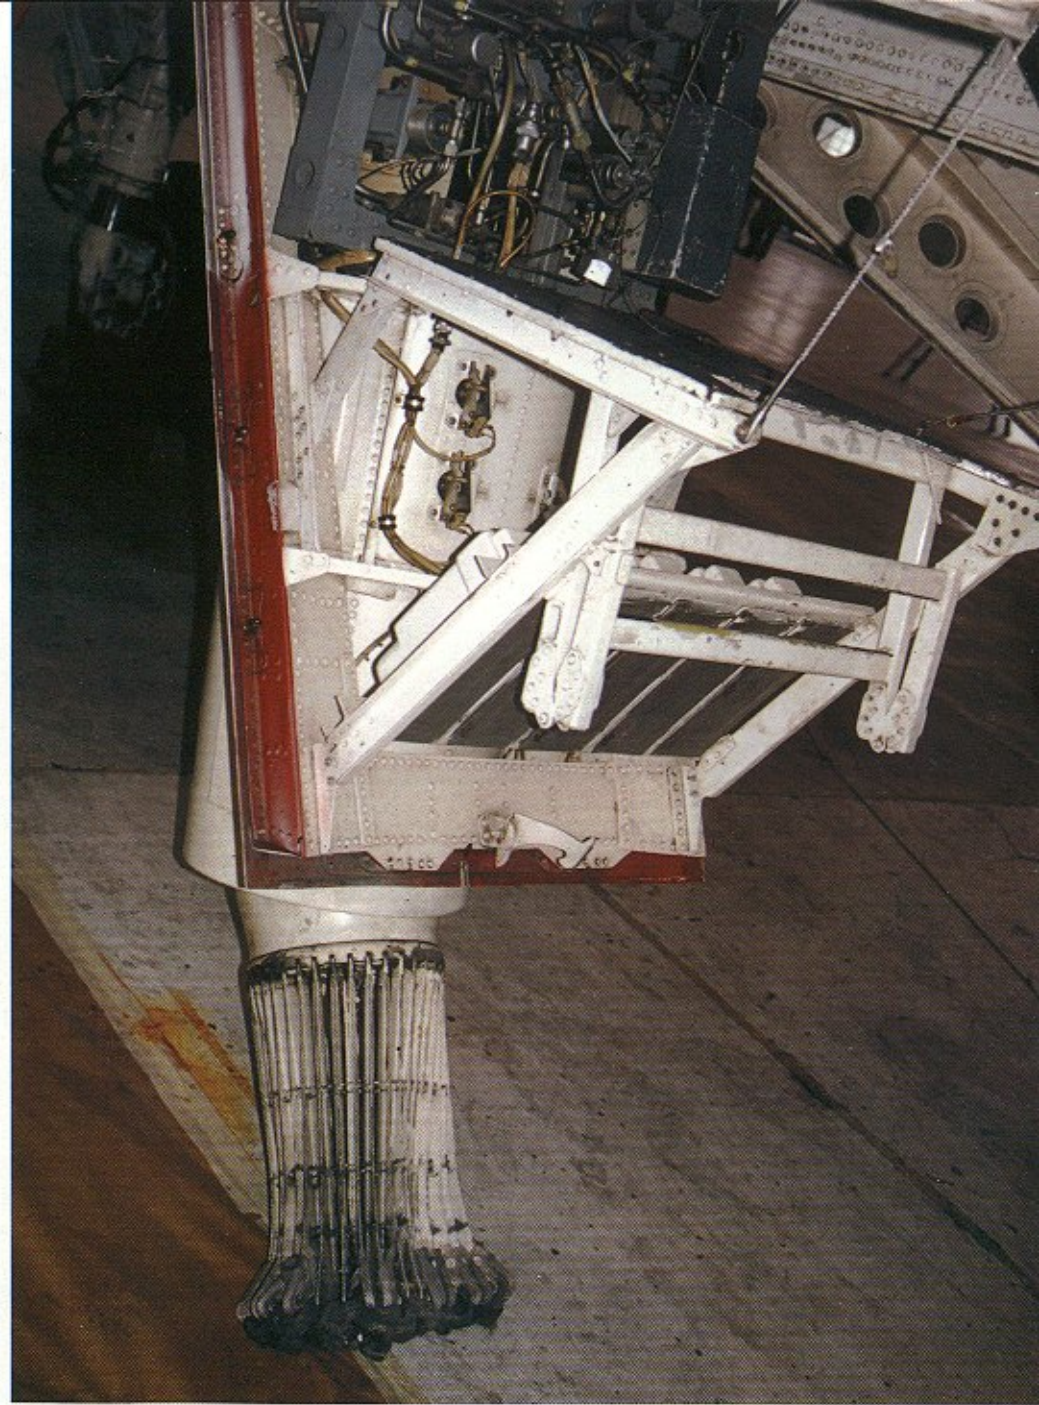
The Extensible Equipment Platform on the KA-6D is hinged at the forward end. This platform contains the refueling Hose/Drum unit. The object at the bottom is the refueling basket that trails below and behind the KA-6 during refueling operations.

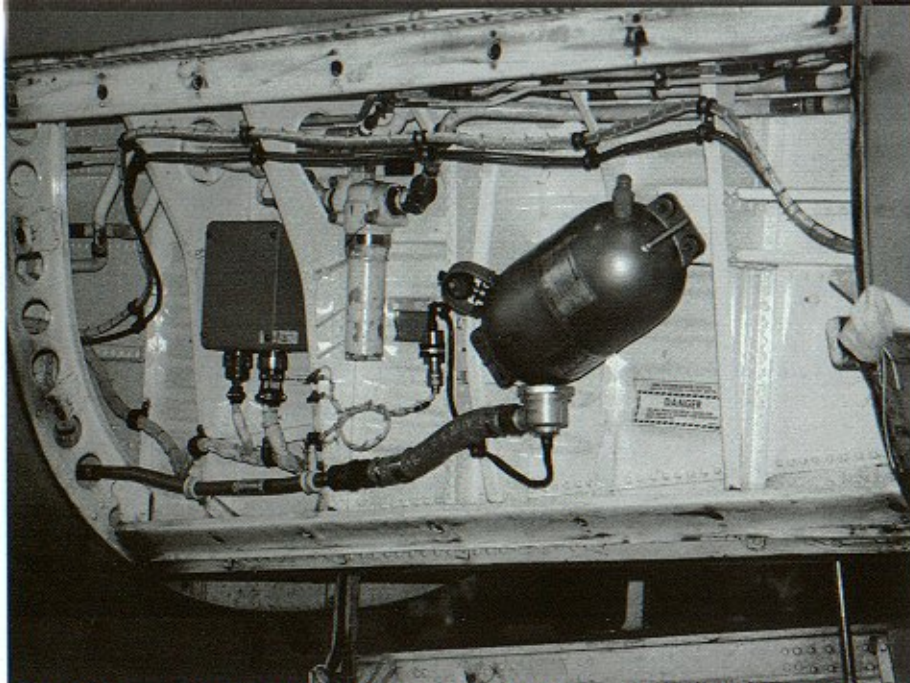
The A-6E does not have fuselage-mounted speed brakes. An equipment bay takes the place of the speed brakes mounted on early A-6As. Normally it is covered by a solid access panel.

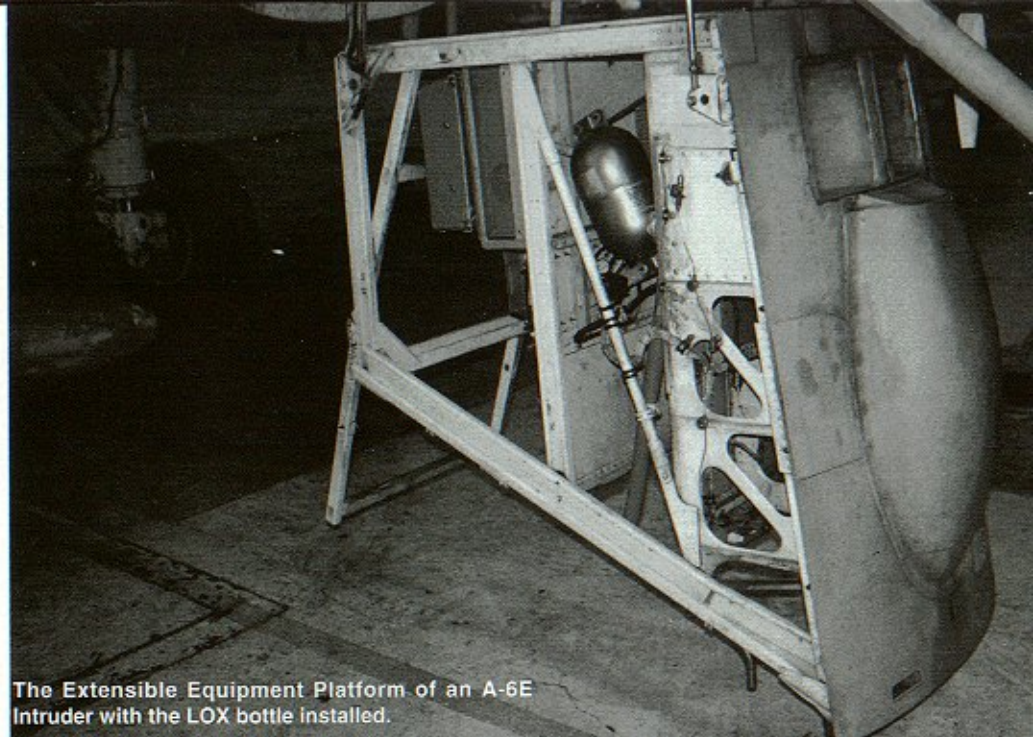
The Extensible Equipment Platform of an A-6E Intruder with the LOX bottle installed.

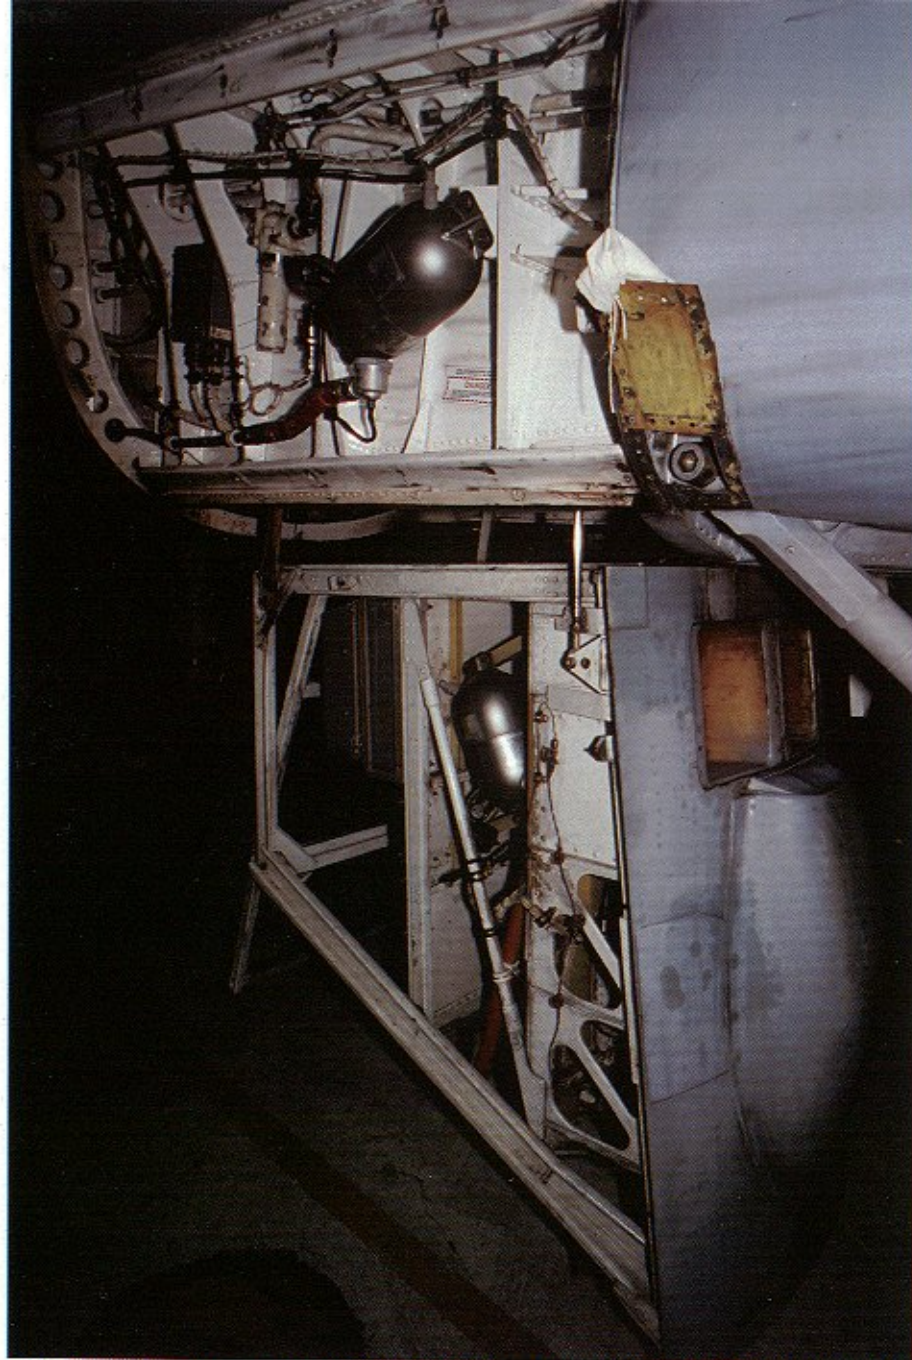
The port side fuselage equipment bay and lowered Extensible Equipment Platform on an A-6E. The legend below the fire extinguisher system bottle reads, "Service If Pressure Is Below 100 PSI." The Danger warning cautions against connecting electrical lines until the bottle is secure and the discharge lines are connected.

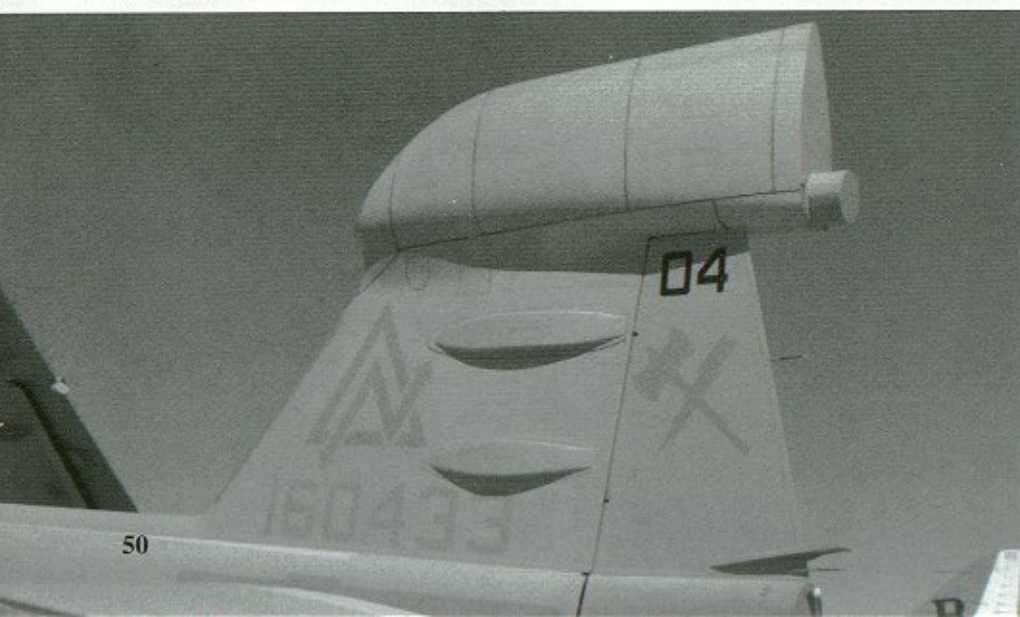
The lower portion of the extreme rear fuselage contains the rear White tall navigation light at the base of the rudder. The vent at the left is the fuselage fuel tank jettison pipe.

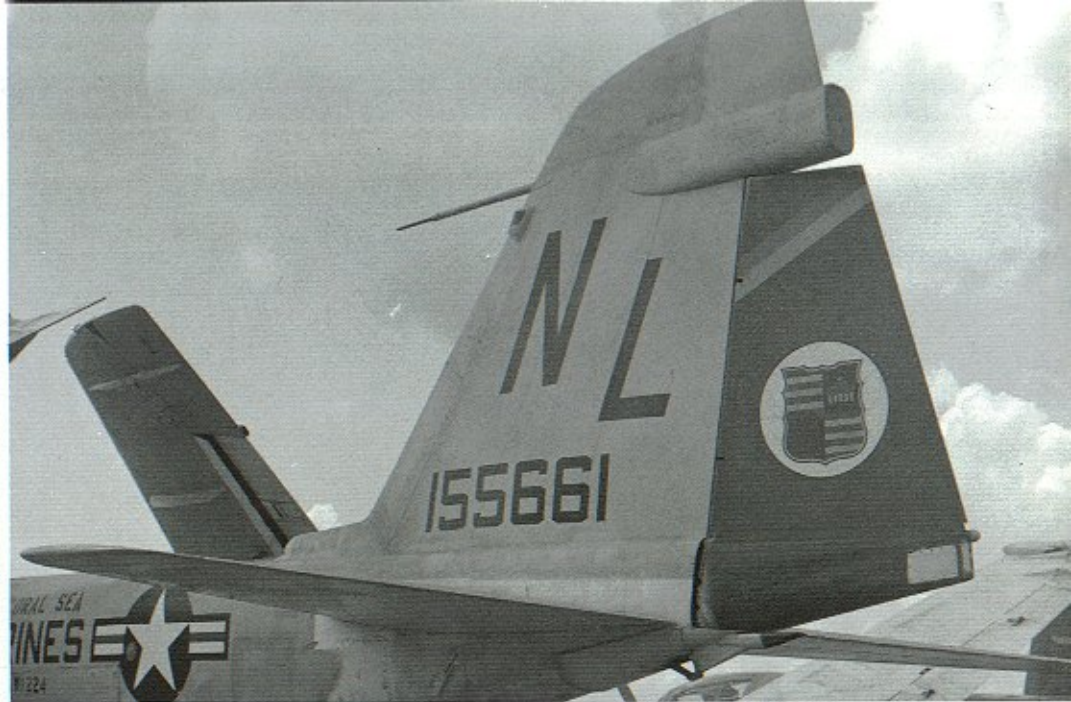
The fin tip of the EA-6A housed the AN/ALQ-86 receiver/surveillance system, AN/ALQ-41 I and J band track breaker and AL/ALQ-100 self-protection system. Additionally, the EA-6A retained the fuselage mounted speed brakes used on early A-6As. Most EA-6As were used by the Marines, like this aircraft of VMCJ-2 at MCAS Cherry Point, North Carolina. On the EA-6A the pitot tube was relocated from the fin to the port wing.

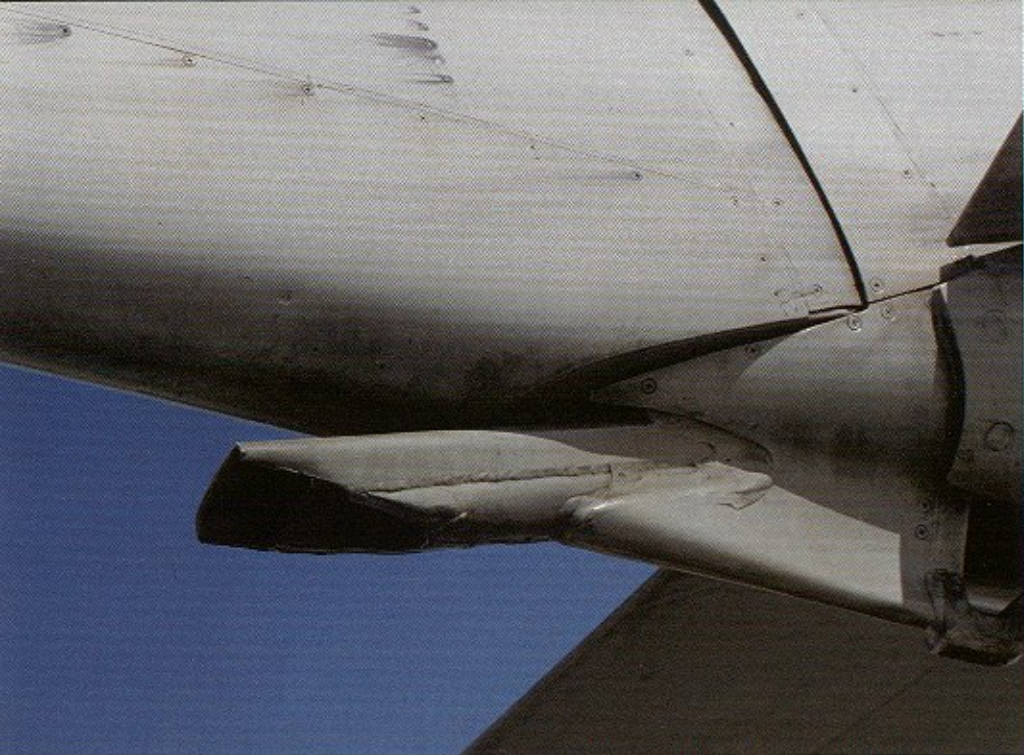
The rear fuselage fuel dump vent on the A-6E is located at the base of the fin. It allows the quick dumping of fuel so the aircraft can get down to landing weight if it returns to the carrier with excess fuel. Landing weight is critical on aircraft carriers and dumping fuel is the method used to control the aircraft's weight.

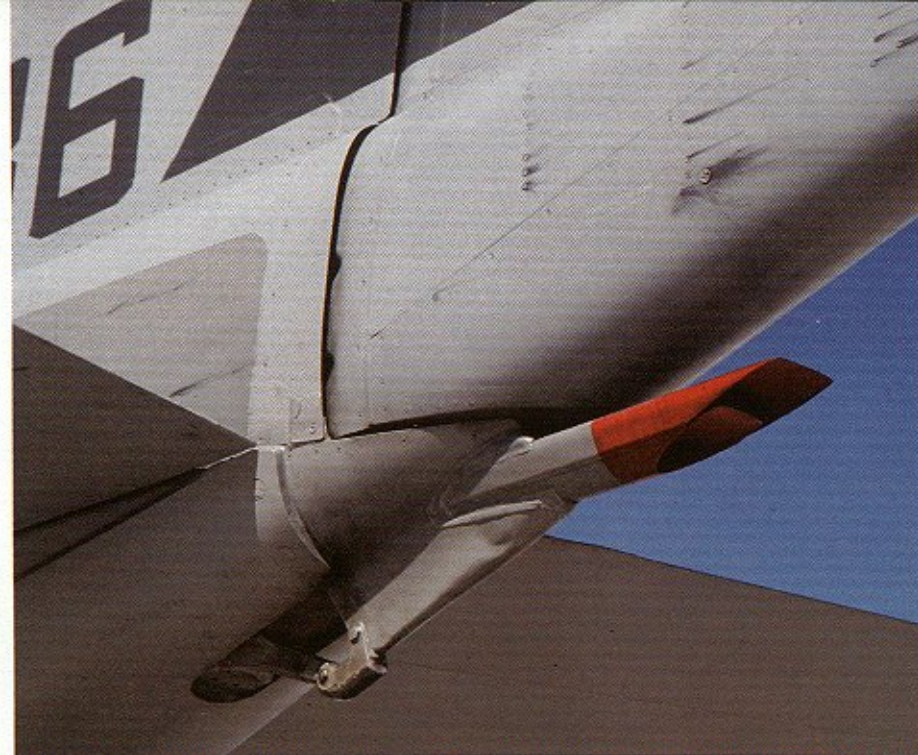
This open access panel on the starboard rear fuselage reveals the stabilator control linkage on an A-6E.

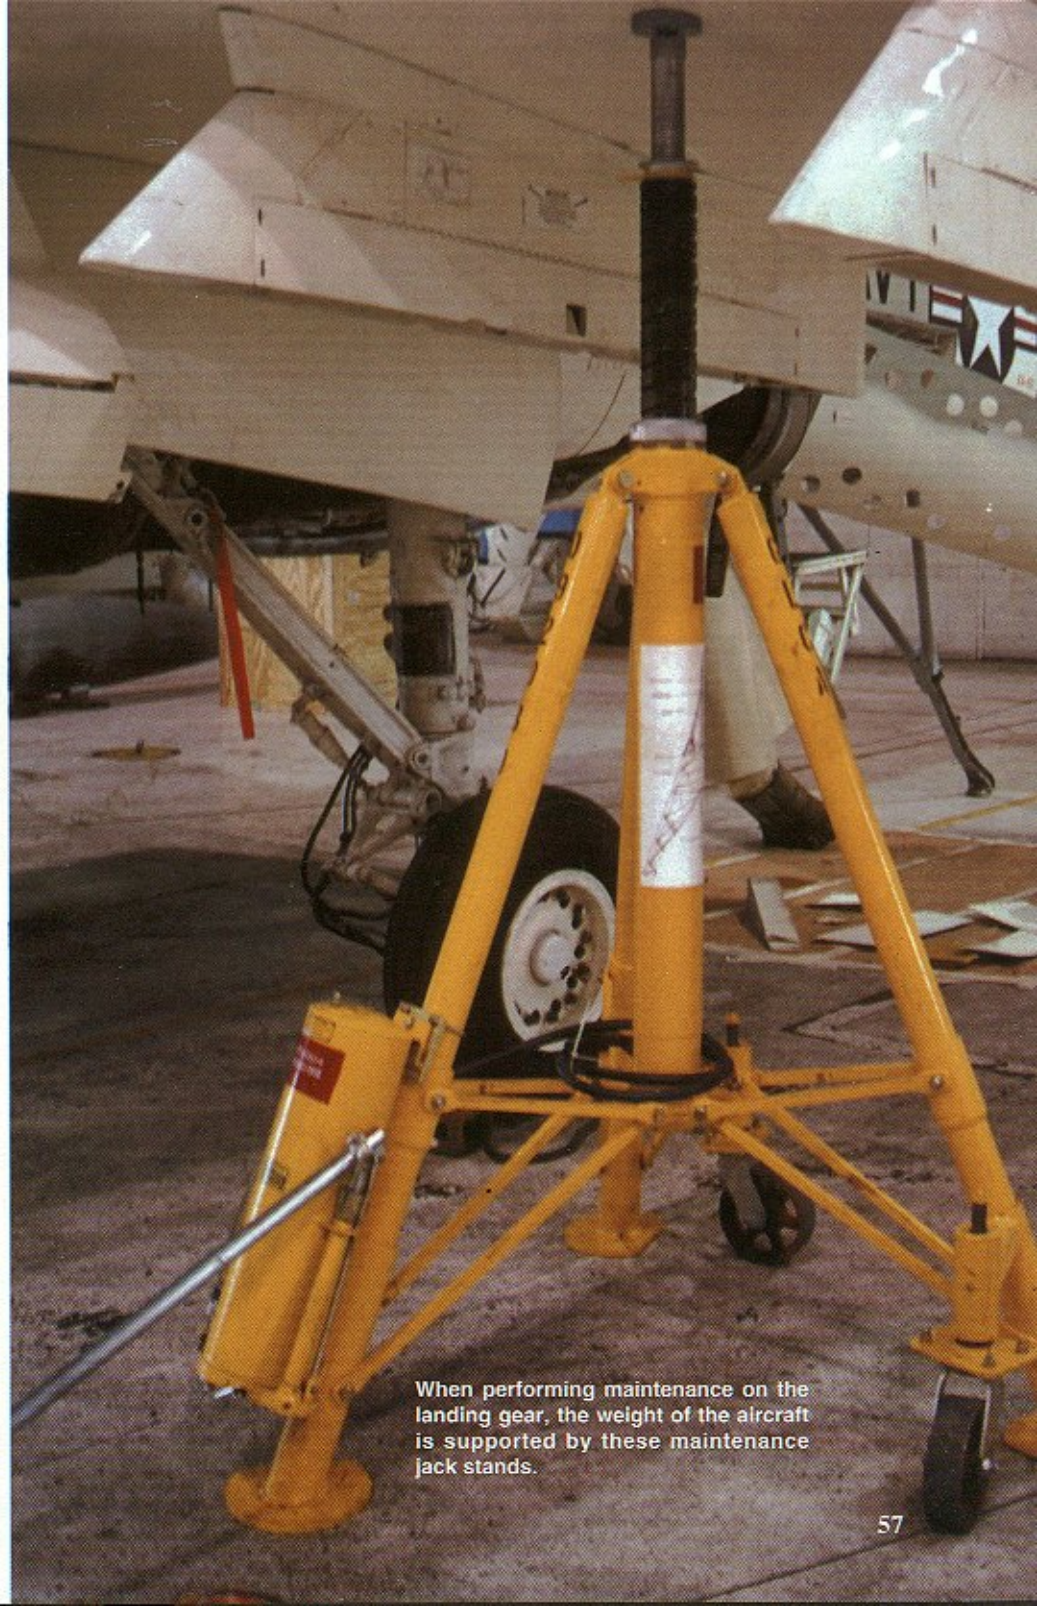
When performing maintenance on the landing gear, the weight of the aircraft is supported by these maintenance jack stands.

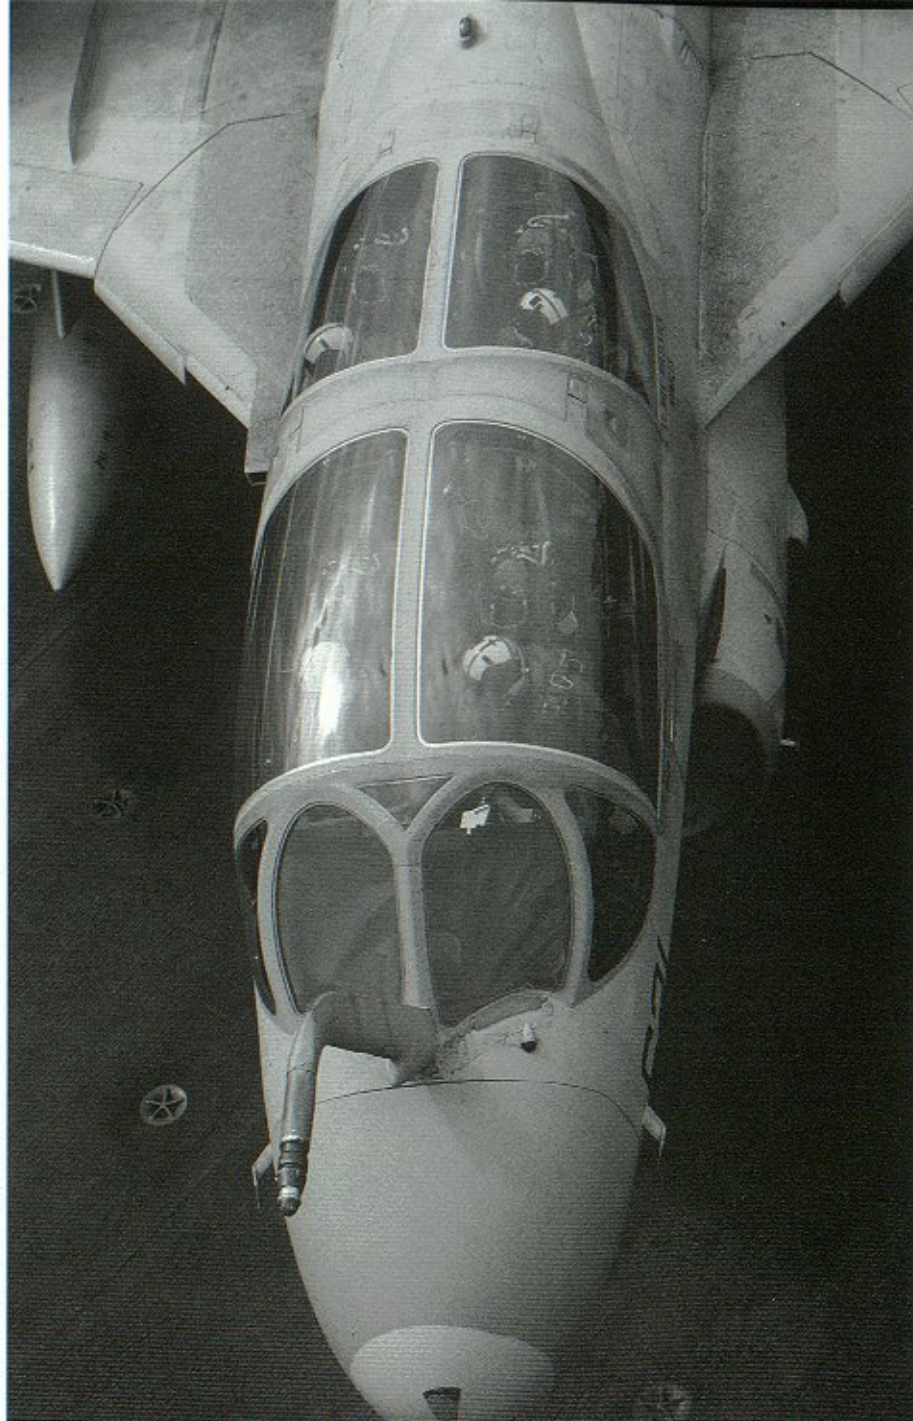
The refueling probe of the EA-6B differs from the standard A-6 series in that it is offset to starboard. The crewmen are seated in Martin-Baker GRUEA-7 ejection seats.

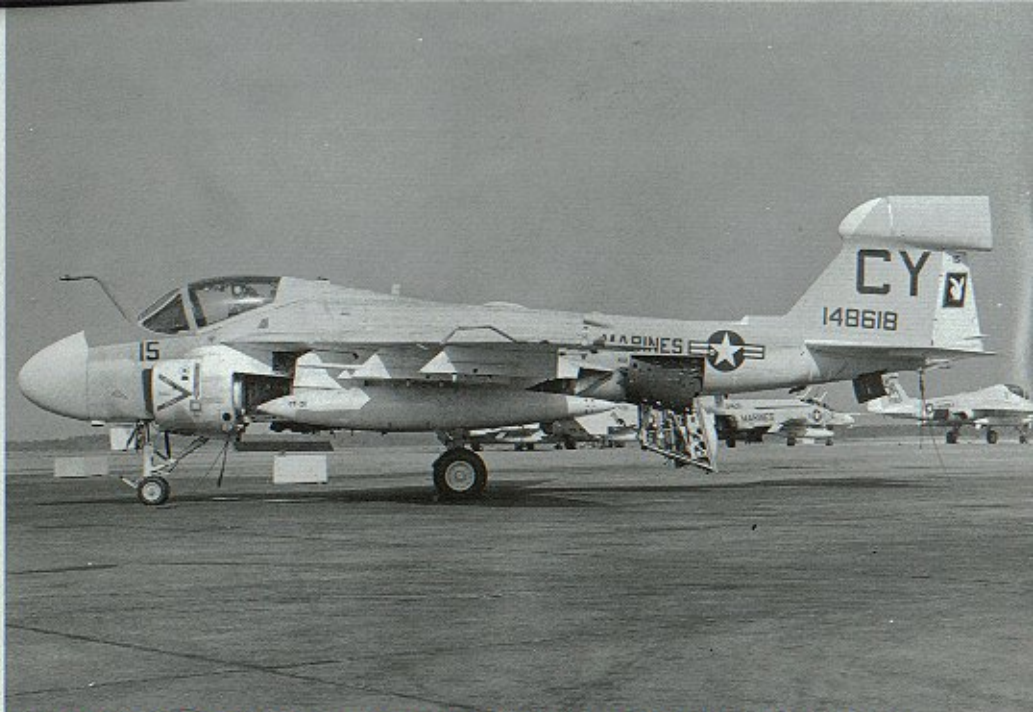
This EA-6A of VMCJ-2 at MCAS Cherry Point has the engine compartment open, the Extensible Equipment Platform lowered and the speed brakes deployed.

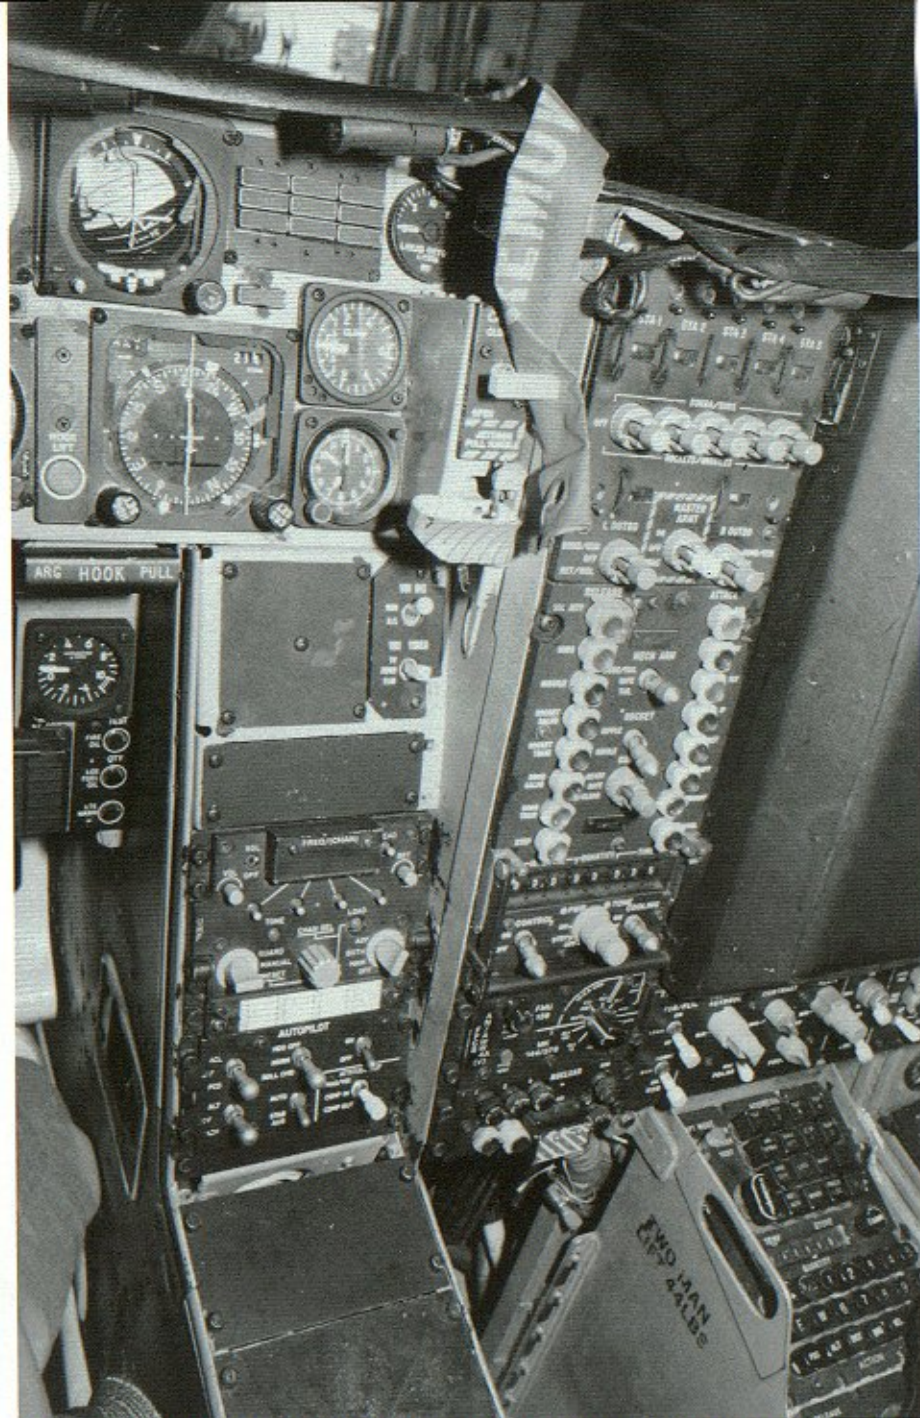
This console contains the autopilot controls (left center) and weapons control panel (right center).

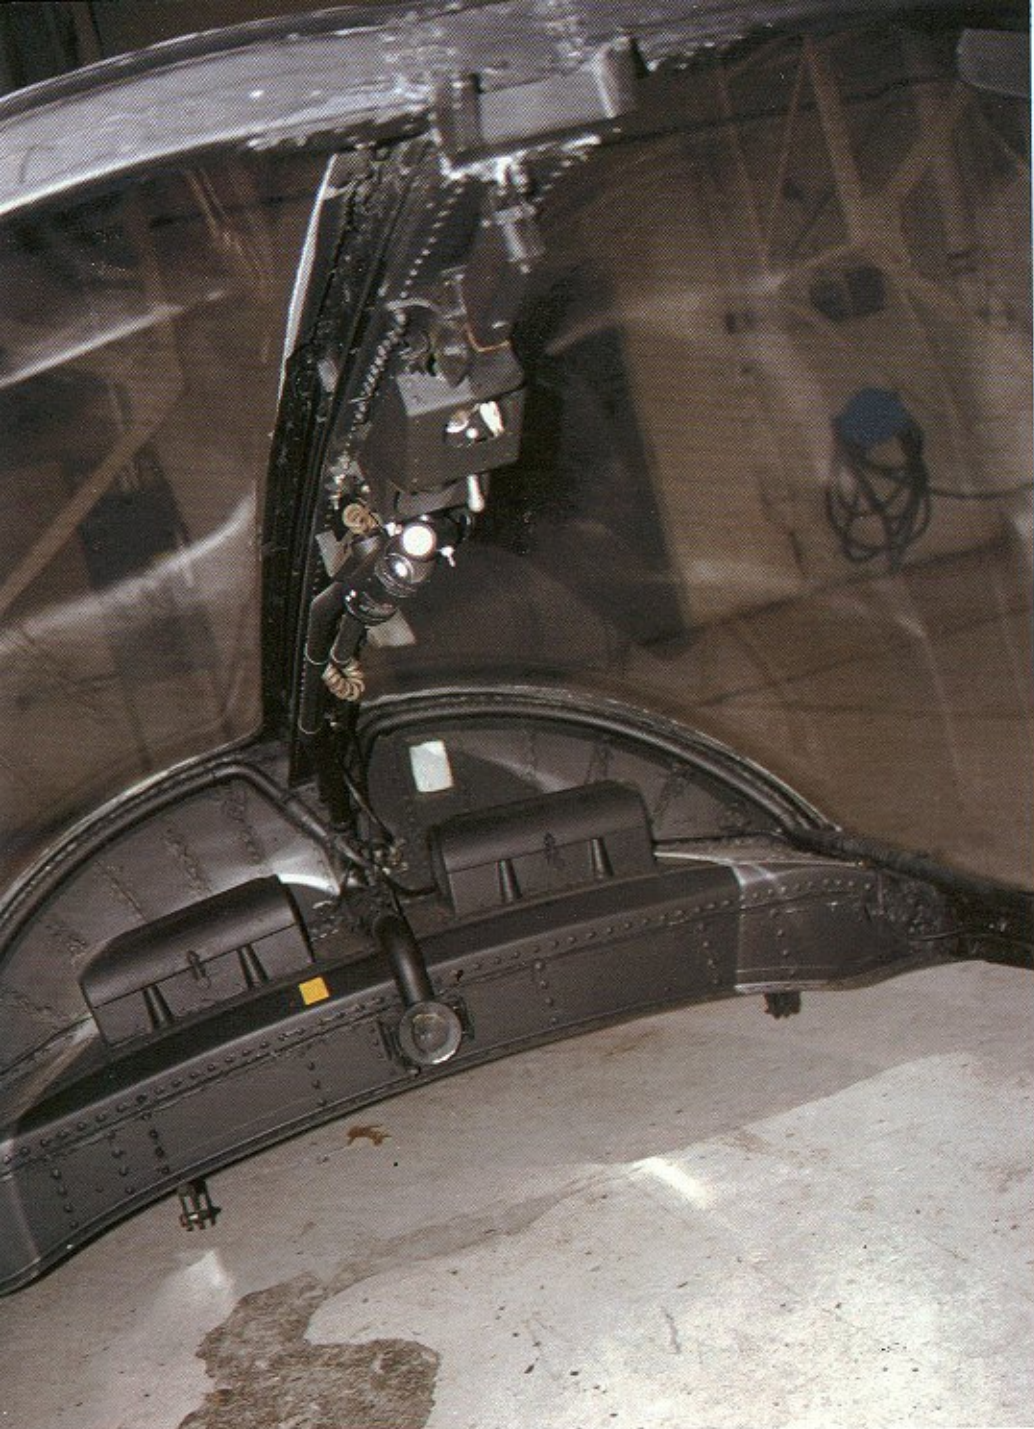
The canopy center framing contains lighting controls and the manual canopy release lever.

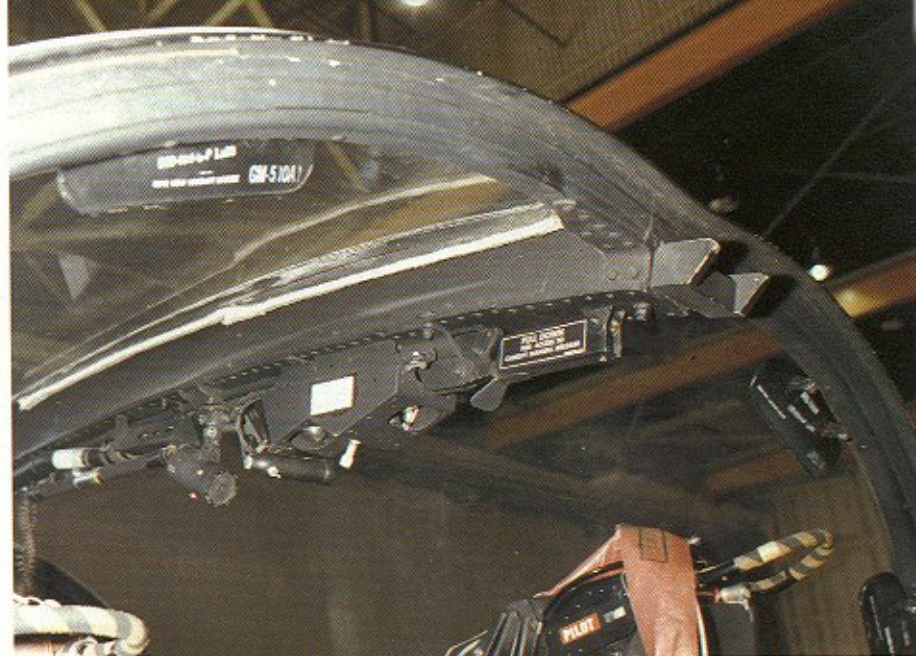
The canopy bow frame has two rear-view mirrors mounted on each side. The instructions on the canopy manual release state to "Pull Down For Access To Canopy Manual Release."

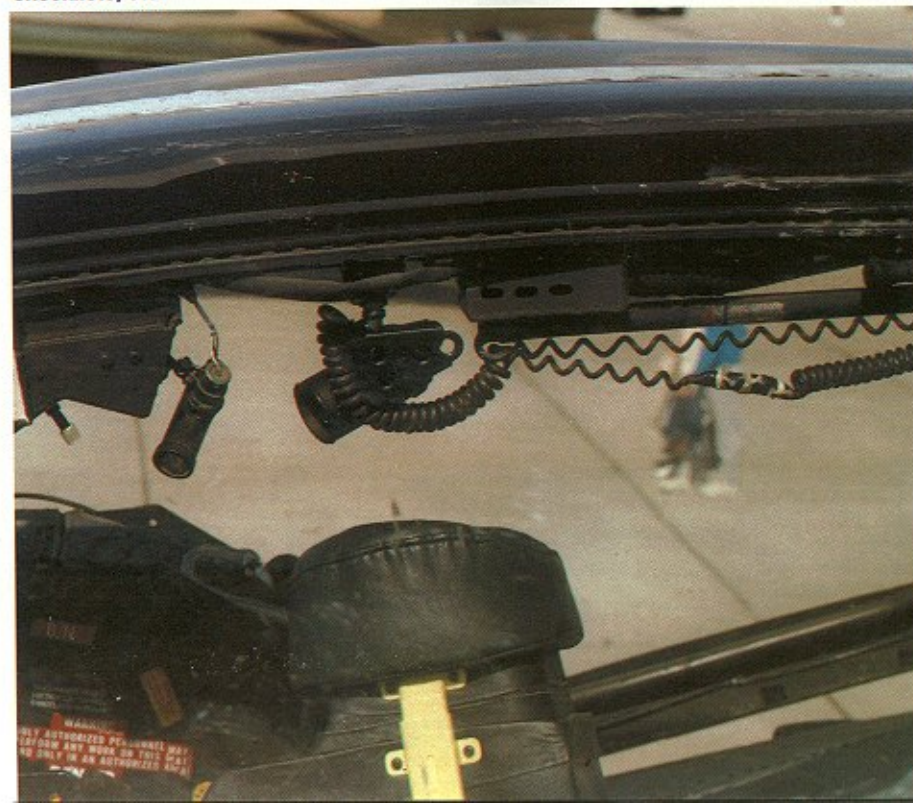
The small lights on the canopy center framing can be trained to illuminate maps, charts, checklists, etc.

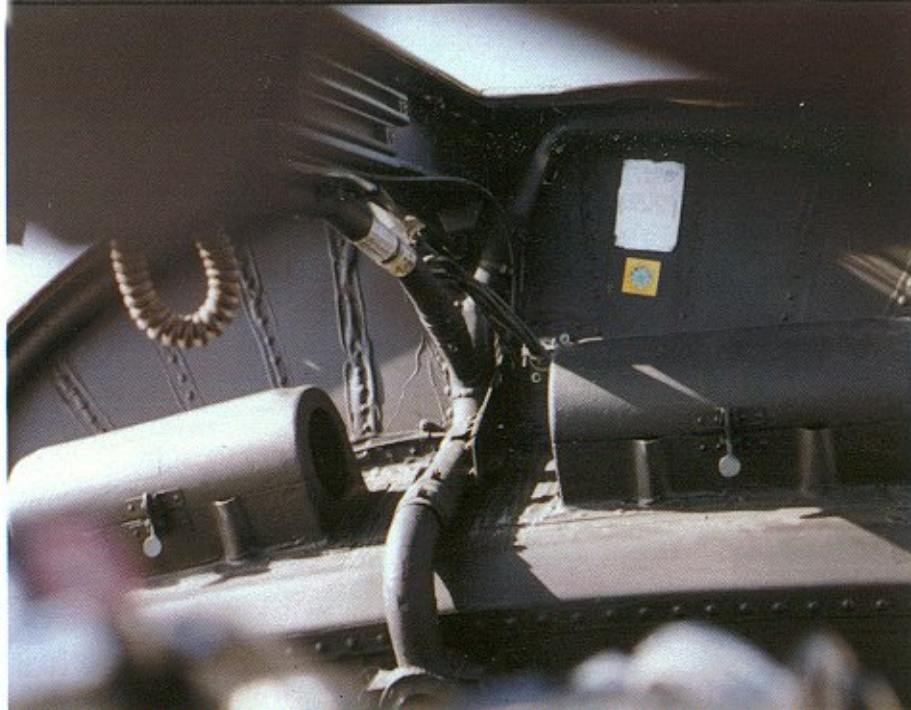
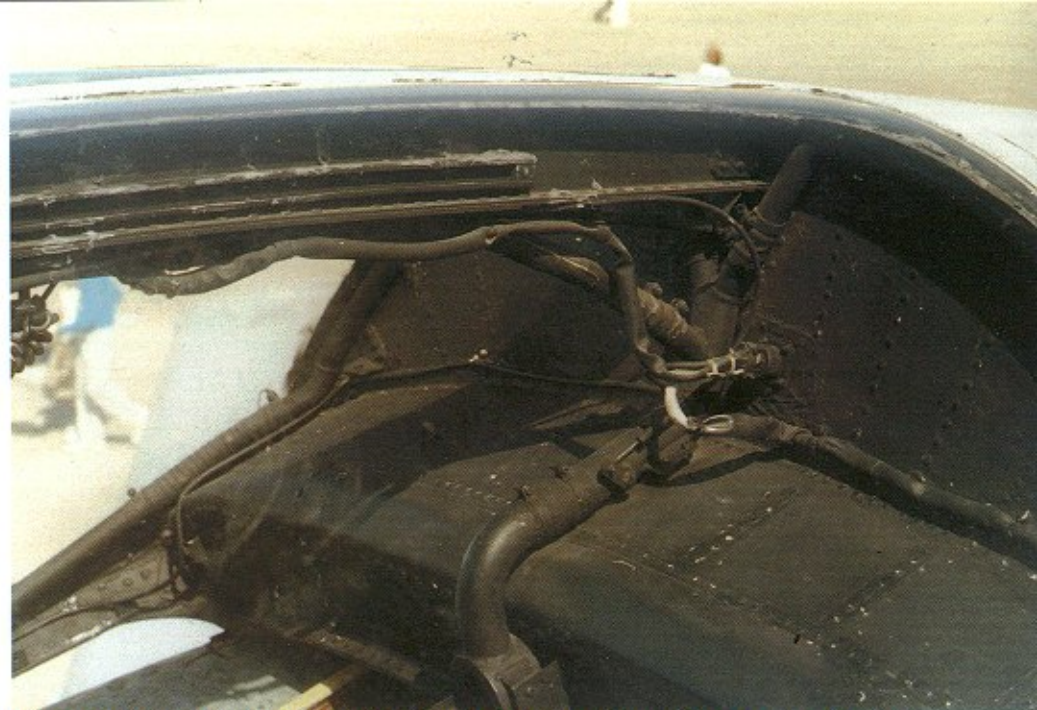
The area behind the cockpit contains electrical junction boxes, a first aid kit, electrical conduits, hydraulic lines, the canopy hydraulic jack piston housing and the weapons monitoring unit computer. The rear canopy bulkhead is painted in Flat Black to reduce reflections in the canopy.

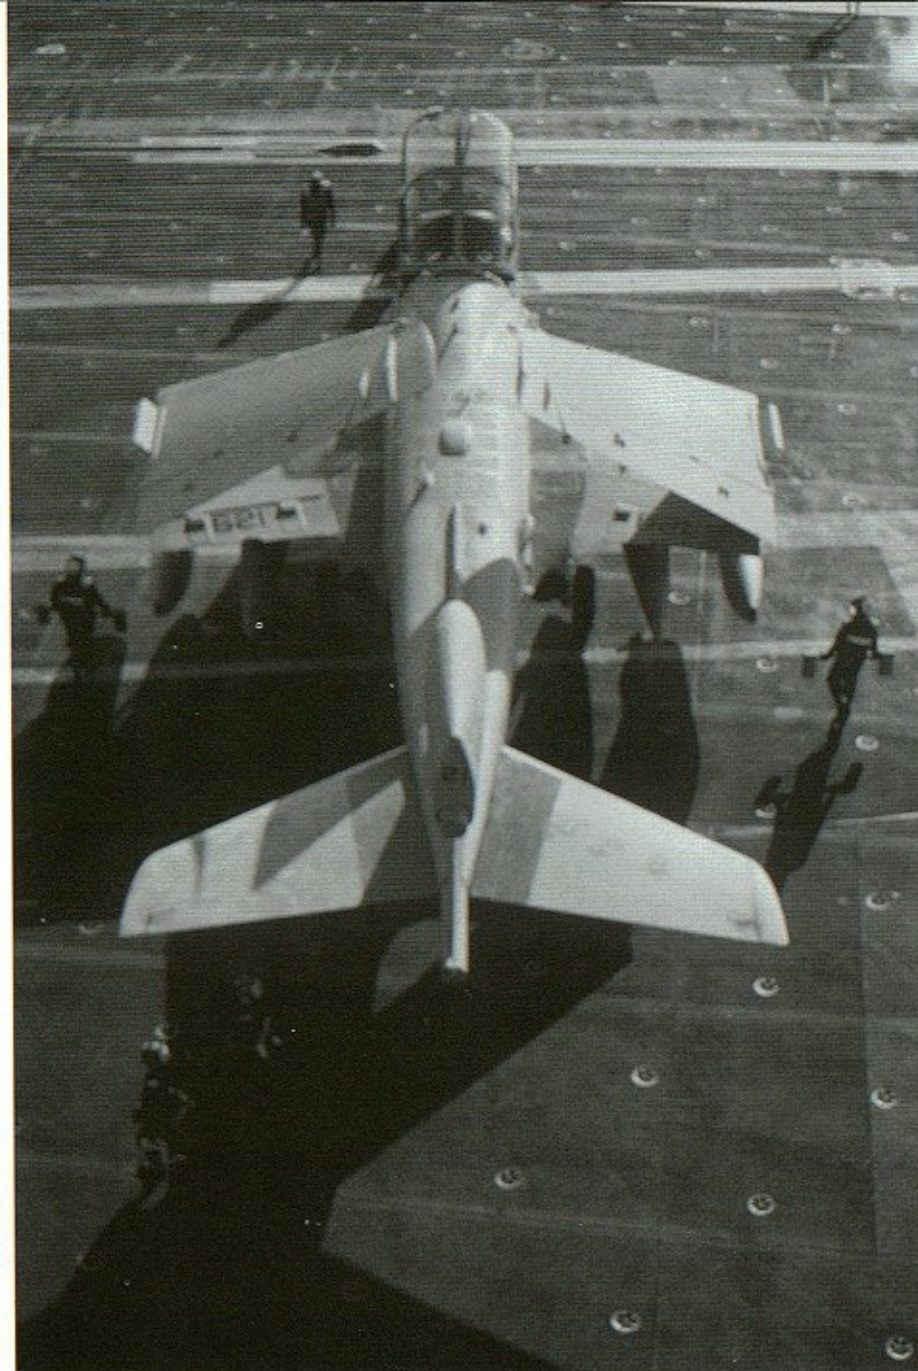
The canopy on the A-6 slides to the rear for entry. The separate canopies of the EA-6B raise upward. This EA-6B of VAQ-131 was aboard USS CONSTELLATION on 7 March 1994.
